November 9, 2016

RE: Asbestos and Lead-Based Paint Inspection
17 East Lake Road, Marlborough, CT
NorthStar Project 161101

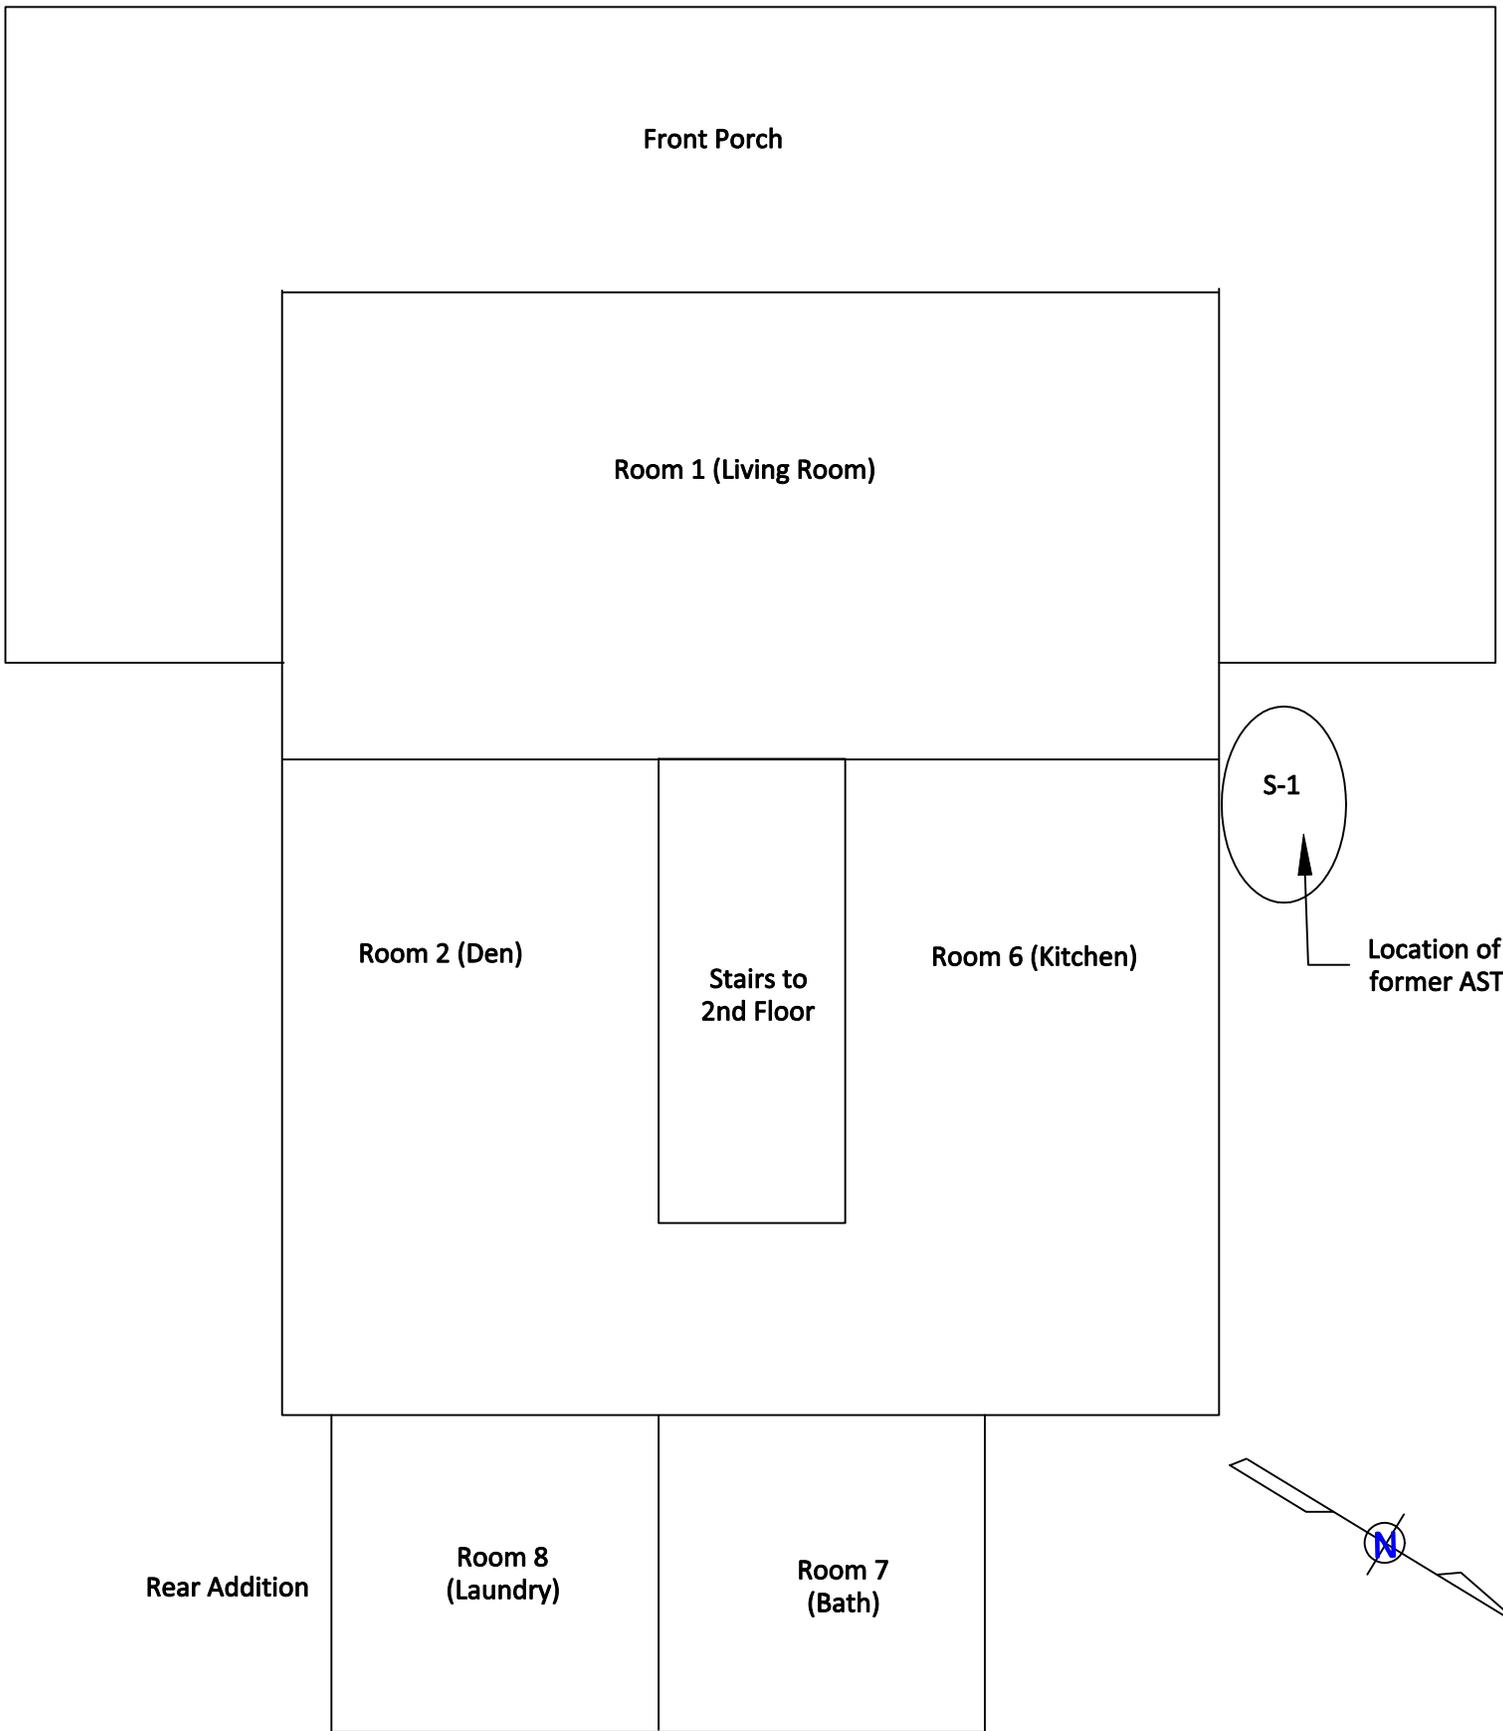
Asbestos sample results are presented in Appendix A. Table 1, presented below, summarizes the building materials that were sampled, indicates the sample locations and material locations, and presents sample results as percent asbestos. Room numbers within the subject building are illustrated in Figures 1 and 2.

Note: ND = not detected; Room designations are illustrated in Figures 1 and 2.
